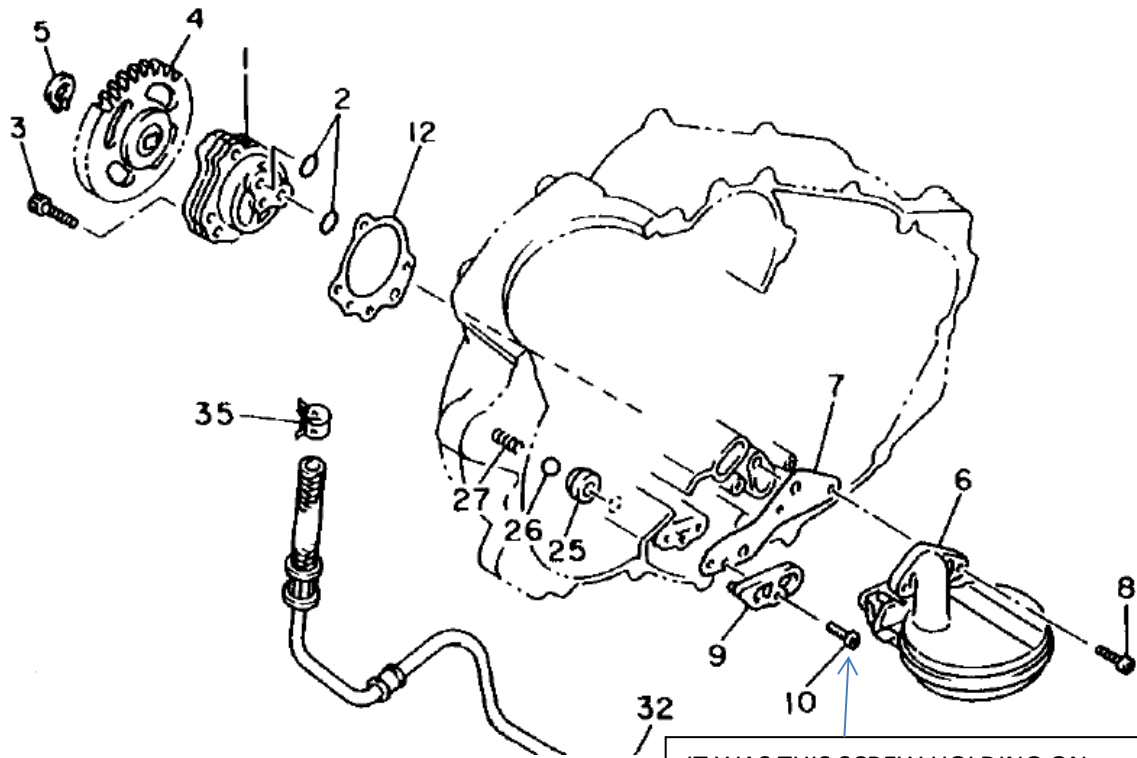
IT WAS THIS SCREW HOLDING ON THE PLATE THAT WAS LOOSE, IT THEREFORE WASN'T TOTALLY SEALING THE PUMP DELIVERY CHAMBER UPTO THE FILTER HOUSING
